# Access Compliance Report Public Rights-of-Way (Curb Ramps)

Main Street: EVENINGSIDE\_DR Cross Street: REDBERRY\_RD Location: NW

ADA ID: RPRK220103123929 Ramp Type: Type 1 - Perpendicular Diagonal Initial Pass/Fail: Pass Overall Compliance: No Severity Score: 2

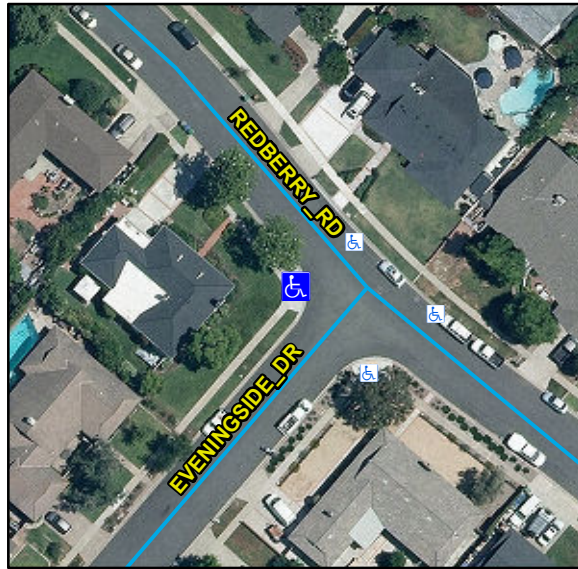
| Compliance | Description | Data | Compliance | Description | Data |
|---|---|---|---|---|---|
| No | Ramp Cross Slope (%) | 2.7 | N/A | Flare Traversable LT | No |
| No | Gutter Cross Slope (%) | 2.5 | | | |

Remove & Replace Curb Ramp With Two New Directional Ramps or Equivalent. Remove & Replace Gutter.

R304.5.3, R304.2.1, STD 1115
