# Access Compliance Report Public Rights-of-Way (Curb Ramps)

Main Street: LA\_COLINA\_DR Cross Street: RANCHWOOD\_RD Location: NE

ADA ID: RPRK220103124449 Ramp Type: Type 4 - Parallel Initial Pass/Fail: Fail Overall Compliance: No Severity Score: 2

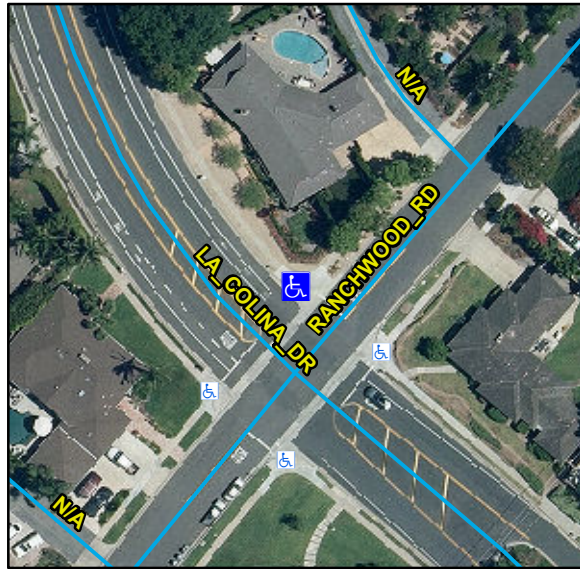
| Compliance | Description | Data | Compliance | Description | Data |
|---|---|---|---|---|---|
| No | Ramp Cross Slope LT (%) | 2.5 | Yes | Ramp Cross Slope RT (%) | 0.9 |

**Remove & Replace Curb Ramp With Two New Directional Ramps or Equivalent.**

**R304.5.3, STD 1115**

Total Cost: \$ 4000
