# Access Compliance Report Public Rights-of-Way (Curb Ramps)

Main Street: RANCHWOOD\_RD Cross Street: IRVINE\_BLV Location: NW

ADA ID: RPRK220103125558 Ramp Type: Type 1 - Perpendicular Diagonal Initial Pass/Fail: Pass Overall Compliance: No Severity Score: 15

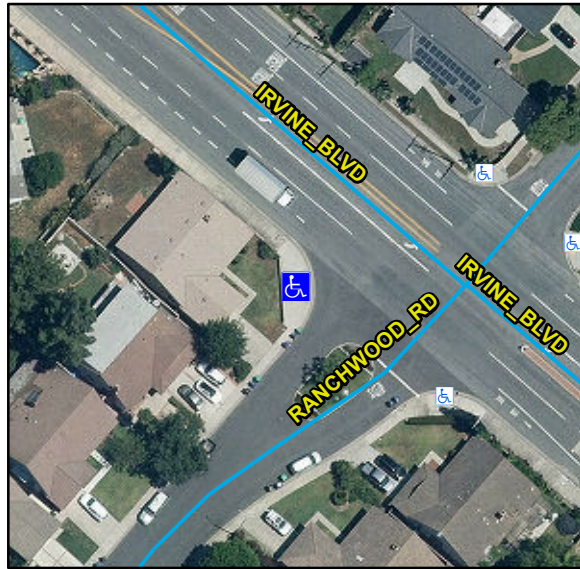
| Compliance | Description | Data | Compliance | Description | Data |
|---|---|---|---|---|---|
| Yes | Landing Cross Slope (%) | 0.7 | No | DWS Provided | No |
| No | Gutter Run Slope (%) | 8.3 | | Road Cross Slope (%) | 2.1 |

Install Detectable Warning System. Remove & Replace Gutter.

R305, R304.5.4, STD 1115
