# Access Compliance Report Public Rights-of-Way (Curb Ramps)

Main Street: IRVINE\_BLVD Cross Street: RANCHWOOD\_RD Location: SW

ADA ID: RPRK220103125924 Ramp Type: Type 1 - Perpendicular Diagonal Initial Pass/Fail: Fail Overall Compliance: No Severity Score: 15

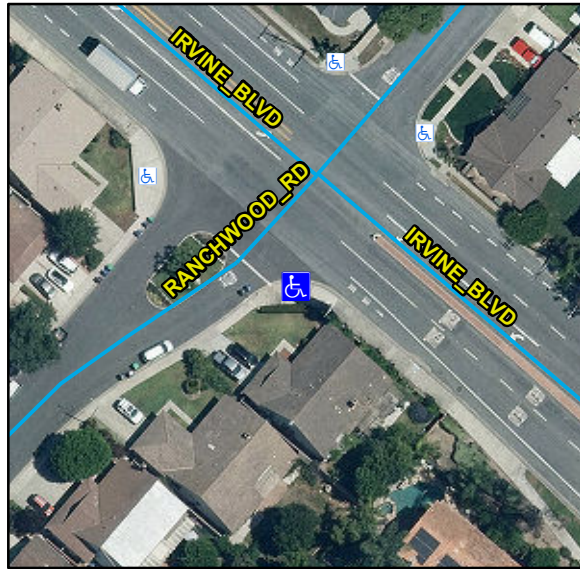
| Compliance | Description | Data | Compliance | Description | Data |
|---|---|---|---|---|---|
| No | Ramp Run Slope (%) | 9.3 | N/A | Flare Slope LT (%) | N/A |

Remove & Replace Curb Ramp With Two New Directional Ramps or Equivalent.

R204.3, R304.2.2, STD 1115
