# Access Compliance Report Public Rights-of-Way (Curb Ramps)

Main Street: TUSTIN\_RANCH\_RD Cross Street: IRVINE\_BLV Location: NW

ADA ID: RPRK220103130403 Ramp Type: Type 1 - Perpendicular Diagonal Initial Pass/Fail: Pass Overall Compliance: No Severity Score: 0

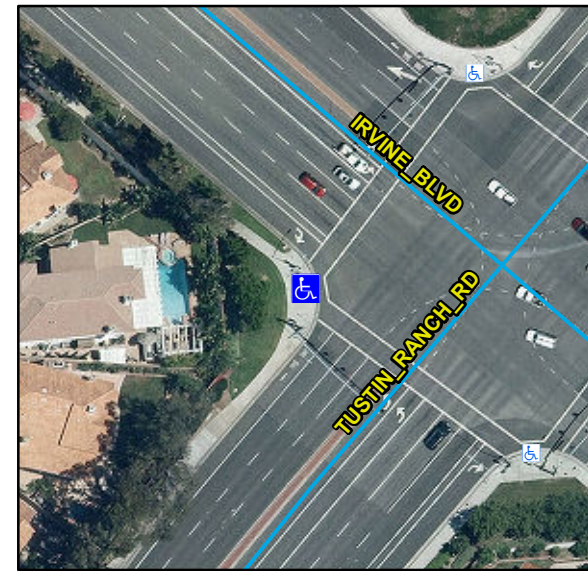
| Compliance | Description | Data | Compliance | Description | Data |
|---|---|---|---|---|---|
| No | Gutter Cross Slope (%) | 2.5 | | | |

Remove & Replace Gutter.

R304.5.3, STD 1115
