# Access Compliance Report Public Rights-of-Way (Curb Ramps)

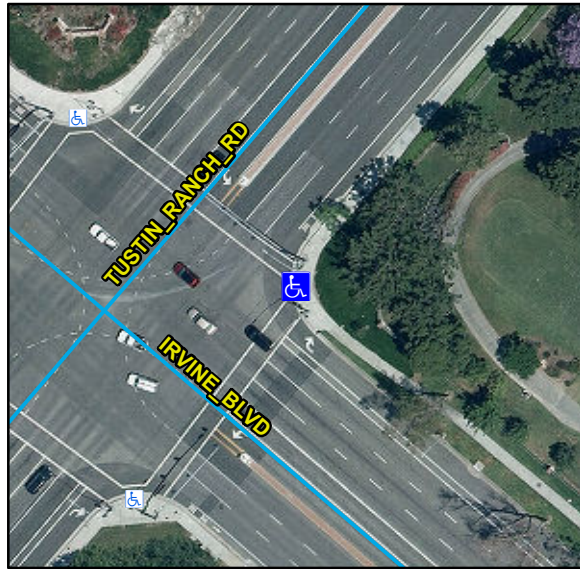
| Compliance | Description | Data | Compliance | Description | Data |
|---|---|---|---|---|---|
| N/A | Landing Present | Yes | N/A | Flare Type RT | |
| N/A | Landing Movement Obstructed? | Yes | Yes | DWS Contrast | Yes |
| | Landing Movement Type | Curb | Yes | DWS Length (in) | 36 |

Possible Solutions:

Remove & Replace Landing.

R304.2.1, STD 1115

Total Cost: \$ 531
