# Access Compliance Report Public Rights-of-Way (Curb Ramps)

Main Street: IRVINE\_BLVD Cross Street: TUSTIN\_RANCH\_RD Location: N

ADA ID: RPRK220103132433 Ramp Type: Type 1 - Perpendicular Diagonal Initial Pass/Fail: Pass Overall Compliance: No Severity Score: 2

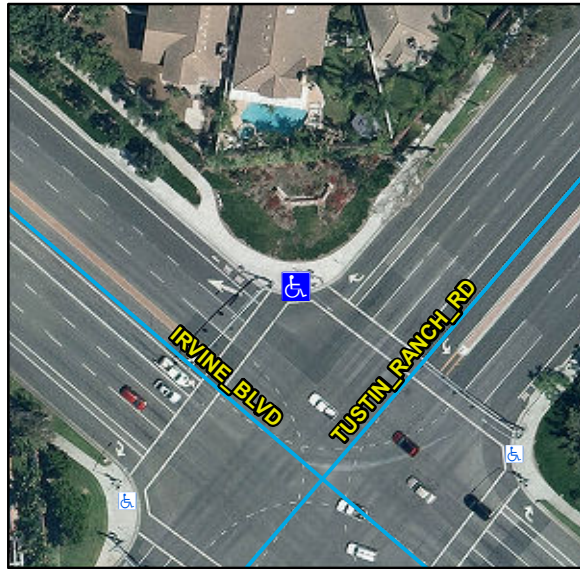
Gutter Ponding Observed.

| Compliance | Description | Data | Compliance | Description | Data |
|---|---|---|---|---|---|
| No | Gutter Ponding | Yes | Yes | Curb Slope | 1.8 |

Possible Solutions:

R302.7, STD 1115
