# Access Compliance Report Public Rights-of-Way (Curb Ramps)

Main Street: IRVINE\_BLVD Cross Street: BROWNING\_AVE Location: NE

ADA ID: RPRK220103133729 Ramp Type: Type 4 - Parallel Initial Pass/Fail: Fail Overall Compliance: No Severity Score: 2

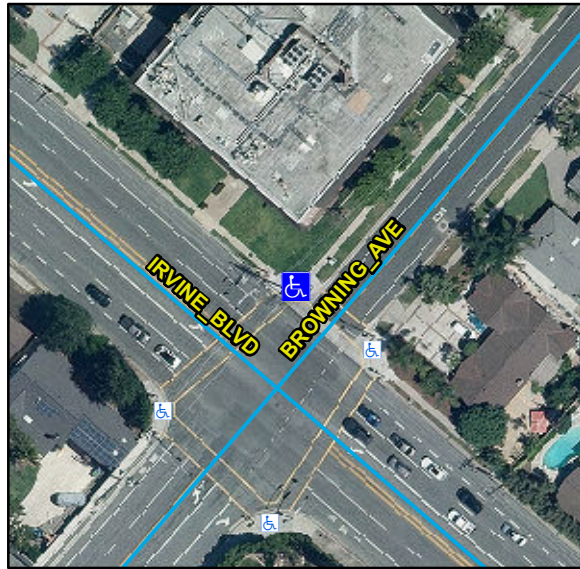
| Compliance | Description | Data | Compliance | Description | Data |
|---|---|---|---|---|---|
| Yes | Ramp Cross Slope LT (%) | 1.5 | No | Ramp Cross Slope RT (%) | 3.9 |

**Remove & Replace Curb Ramp With Two New Directional Ramps or Equivalent.**

**R304.5.3, STD 1115**

Total Cost: \$ 4000
