# Access Compliance Report Public Rights-of-Way (Curb Ramps)

Main Street: WICKSHIRE\_LN Cross Street: BELLEFORD\_RD Location: W

ADA ID: RPRK220103134930 Ramp Type: Type 1 - Perpendicular Diagonal Initial Pass/Fail: Pass Overall Compliance: No Severity Score: 10

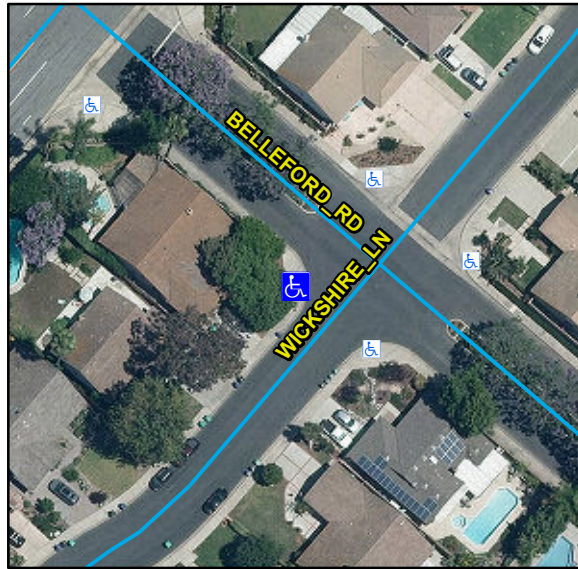
| Compliance | Description | Data | Compliance | Description | Data |
|---|---|---|---|---|---|
| Yes | Landing Cross Slope (%) | 0.9 | No | DWS Provided | No |

**Remove & Replace Curb Ramp With Two New Directional Ramps or Equivalent.**

**R304.2.1, R305, STD 1115**
