# Access Compliance Report Public Rights-of-Way (Curb Ramps)

Main Street: BELLEFORD\_RD Cross Street: WICKSHIRE\_LN Location: N

ADA ID: RPRK220103135240 Ramp Type: Type 1 - Perpendicular Diagonal Initial Pass/Fail: Pass Overall Compliance: No Severity Score: 16

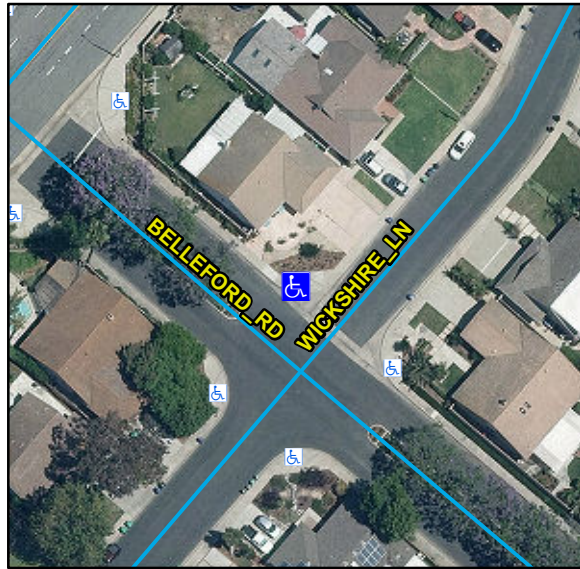
| Compliance | Description | Data | Compliance | Description | Data |
|---|---|---|---|---|---|
| Yes | Landing Cross Slope (%) | 0.9 | No | DWS Provided | No |
| No | Gutter Lip Height (in) | 0.25 | | Road Run Slope (%) | 0.4 |

**Remove & Replace Curb Ramp With Two New Directional Ramps or Equivalent. Grind Gutter Lip.**

**R204.3, R304.2.1, R305, R302.7.2, STD 1115**
