# Access Compliance Report Public Rights-of-Way (Curb Ramps)

Main Street: WICKSHIRE\_LN Cross Street: BELLEFORD\_RD Location: SE

ADA ID: RPRK220103135532 Ramp Type: Type 1 - Perpendicular Diagonal Initial Pass/Fail: Pass Overall Compliance: No Severity Score: 10

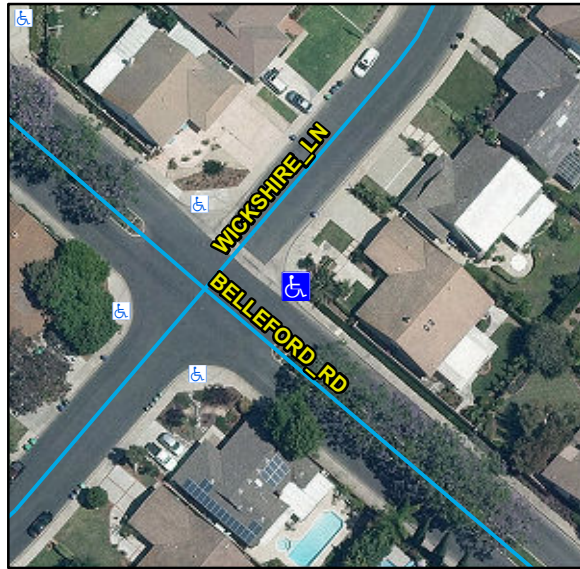
| Compliance | Description | Data | Compliance | Description | Data |
|---|---|---|---|---|---|
| Yes | Landing Cross Slope (%) | 1.3 | No | DWS Provided | No |

**Remove & Replace Curb Ramp With Two New Directional Ramps or Equivalent.**

**R304.2.1, R305, STD 1115**
