# Access Compliance Report Public Rights-of-Way (Curb Ramps)

Main Street: BELLEFORD\_RD Cross Street: WICKSHIRE\_LN Location: S

ADA ID: RPRK220103135828 Ramp Type: Type 1 - Perpendicular Diagonal Initial Pass/Fail: Pass Overall Compliance: No Severity Score: 15

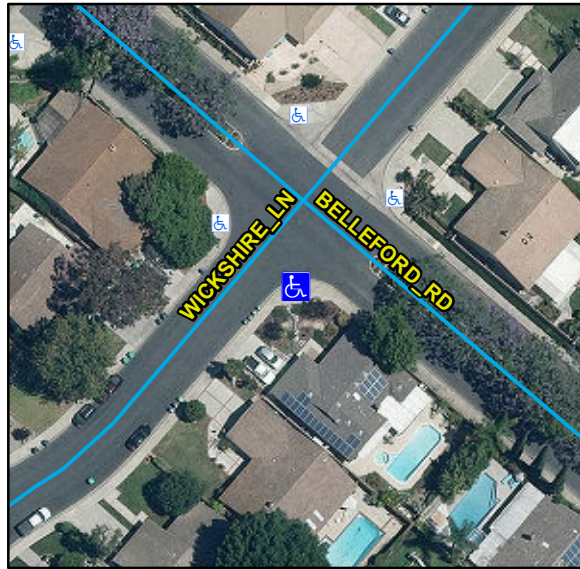
| Compliance | Description | Data | Compliance | Description | Data |
|---|---|---|---|---|---|
| Yes | Landing Cross Slope (%) | 1.7 | No | DWS Provided | No |
| No | Gutter Lip Height (in) | 0.25 | | Road Run Slope (%) | 1.4 |
| No | Gutter Run Slope (%) | 6.9 | | Road Cross Slope (%) | 4.9 |

**Remove & Replace Curb Ramp With Two New Directional Ramps or Equivalent. Remove & Replace Gutter.**

**R304.2.1, R305, R302.7.2, R304.5.4, STD 1115**
