# Access Compliance Report Public Rights-of-Way (Curb Ramps)

Main Street: **CHIRPING\_SPARROW\_WAY** Cross Street: **RIVERFORD\_RD** Location: **W**

ADA ID: **RPRK220103140935** Ramp Type: **Type 4 - Parallel** Initial Pass/Fail: **Fail** Overall Compliance: **No** Severity Score: **16**

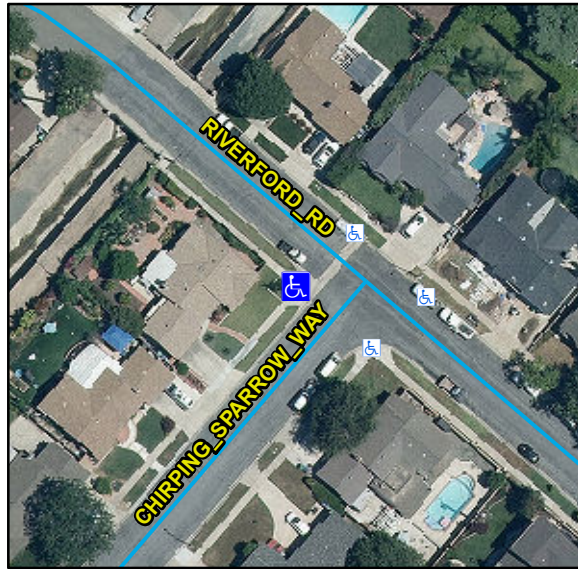
| Compliance | Description | Data | Compliance | Description | Data |
|---|---|---|---|---|---|
| <b>Yes</b> | Ramp Run Slope LT (%) | <b>0.9</b> | <b>No</b> | Ramp Run Slope RT (%) | <b>8.9</b> |
| <b>Yes</b> | Ramp Cross Slope LT (%) | <b>0.3</b> | <b>No</b> | Ramp Cross Slope RT (%) | <b>5</b> |

**Remove & Replace Curb Ramp With Two New Directional Ramps or Equivalent.**

**R304.3.2, R304.5.3, STD 1115**
