# Access Compliance Report Public Rights-of-Way (Curb Ramps)

Main Street: RIVERFORD\_RD Cross Street: CHIRPING\_SPARROW\_WAY Location: S

ADA ID: RPRK220103141214 Ramp Type: Type 4 - Parallel Initial Pass/Fail: Fail Overall Compliance: No Severity Score: 2

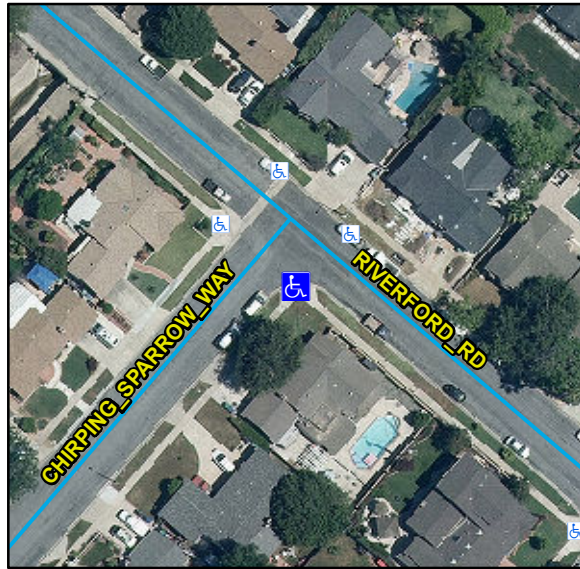
| Compliance | Description | Data | Compliance | Description | Data |
|---|---|---|---|---|---|
| No | Ramp Cross Slope LT (%) | 2.4 | Yes | Ramp Cross Slope RT (%) | 1.4 |

**Remove & Replace Curb Ramp With Two New Directional Ramps or Equivalent.**

**R204.3, R304.5.3, STD 1115**
