# Access Compliance Report Public Rights-of-Way (Curb Ramps)

Main Street: BUBBLING\_WELL\_RD Cross Street: RIVERFORD\_RD Location: NW

ADA ID: RPRK220103141439 Ramp Type: Type 4 - Parallel Initial Pass/Fail: Pass Overall Compliance: No Severity Score: 25

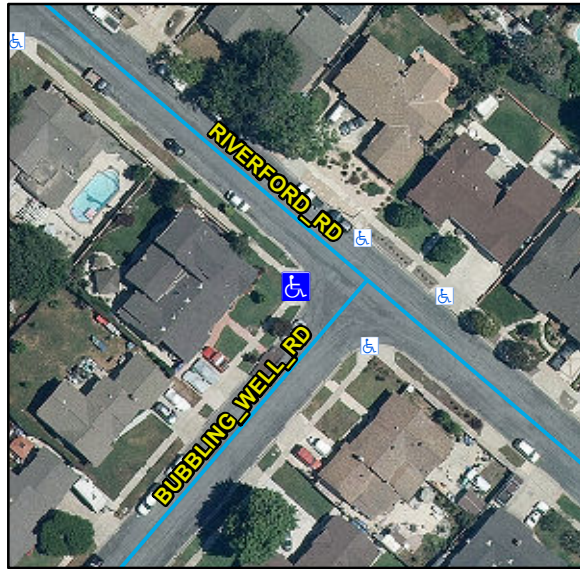
| Compliance | Description | Data | Compliance | Description | Data |
|---|---|---|---|---|---|
| N/A | Landing Present | No | No | DWS Provided | No |
| No | Landing Width (in) | N/A | N/A | DWS Length (in) | N/A |
| No | Landing Run Slope (%) | N/A | N/A | DWS Full Width | N/A |
| No | Landing Cross Slope (%) | N/A | | DWS Offset Type | N/A |
| No | Gutter Run Slope (%) | 9.6 | | Road Cross Slope (%) | 4.9 |
| Yes | Gutter Cross Slope (%) | 1.7 | No | Perpendicular Joint Present | No |

**Remove & Replace Curb Ramp With Two New Directional Ramps or Equivalent. Remove & Replace Gutter.**

**R204.3, R304.2.1, R304.2.2-Perp, R304.3.2-Para, R304.5.3, R305, R304.5.4, STD 1115**
