# Access Compliance Report Public Rights-of-Way (Curb Ramps)

Main Street: RIVERFORD\_RD Cross Street: BUBBLING\_WELL\_RD Location: S

ADA ID: RPRK220103141758 Ramp Type: Type 4 - Parallel Initial Pass/Fail: Pass Overall Compliance: No Severity Score: 20

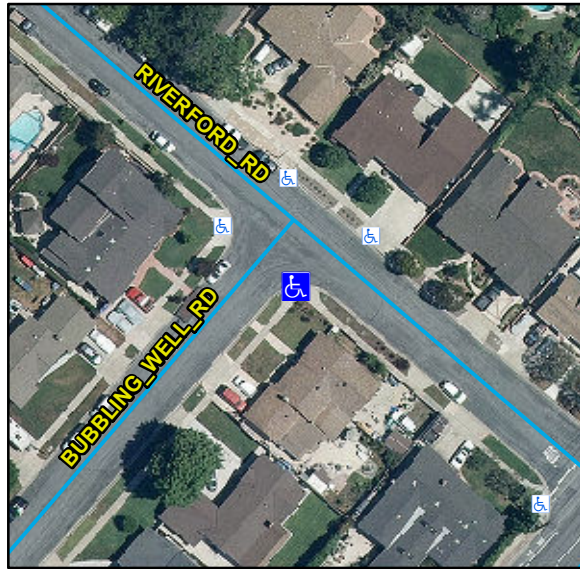
| Compliance | Description | Data | Compliance | Description | Data |
|---|---|---|---|---|---|
| N/A | Landing Present | No | No | DWS Provided | No |
| No | Landing Width (in) | N/A | N/A | DWS Length (in) | N/A |
| No | Landing Run Slope (%) | N/A | N/A | DWS Full Width | N/A |
| No | Landing Cross Slope (%) | N/A | | DWS Offset Type | N/A |

Remove & Replace Curb Ramp With Two New Directional Ramps or Equivalent.
