# Access Compliance Report Public Rights-of-Way (Curb Ramps)

Main Street: **CHIRPING\_SPARROW\_WAY** Cross Street: **BENT\_TWIG\_LN** Location: **E**

ADA ID: **RPRK220103142334** Ramp Type: **Type 1 - Perpendicular Diagonal Initial Pass/Fail: Pass** Overall Compliance: **No** Severity Score: **4**

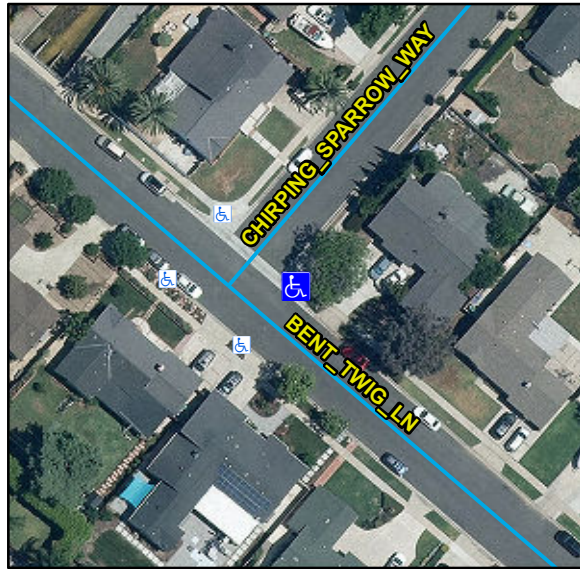
| Compliance | Description | Data | Compliance | Description | Data |
|---|---|---|---|---|---|
| <b>No</b> | Landing Run Slope (%) | <b>2.5</b> | <b>N/A</b> | Flare Traversable RT | <b>No</b> |

**Remove & Replace Landing.**

**R304.2.1, R304.2.2-Perp, R304.3.2-Para, STD 1115**
