# Access Compliance Report Public Rights-of-Way (Curb Ramps)

Main Street: BENT\_TWIG\_LN Cross Street: CHIRPING\_SPARROW\_WAY Location: N

ADA ID: RPRK220103142615 Ramp Type: Type 1 - Perpendicular Diagonal Initial Pass/Fail: Pass Overall Compliance: No Severity Score: 6

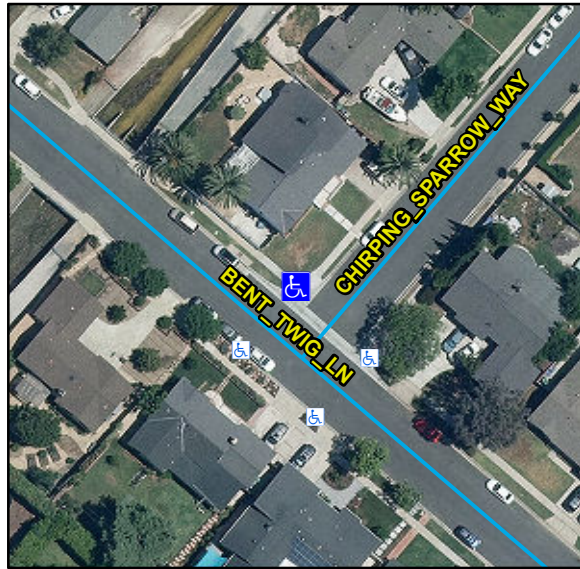
| Compliance | Description | Data | Compliance | Description | Data |
|---|---|---|---|---|---|
| No | Landing Run Slope (%) | 2.6 | N/A | Flare Traversable RT | No |

Remove & Replace Landing.

R304.2.1, R304.2.2-Perp, R304.3.2-Para, STD 1115
