# Access Compliance Report Public Rights-of-Way (Curb Ramps)

Main Street: HICKORY\_BRANCH\_RD Cross Street: TIFFANY\_PL Location: NW

ADA ID: RPRK220103143521 Ramp Type: Type 4 - Parallel Initial Pass/Fail: Fail Overall Compliance: No Severity Score: 2

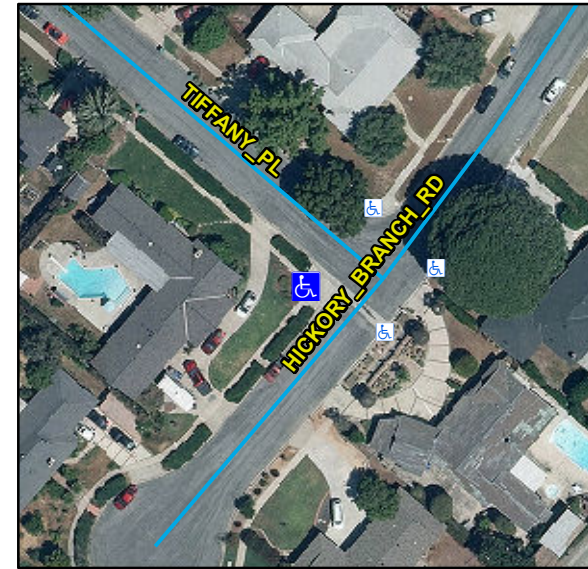
| Compliance | Description | Data | Compliance | Description | Data |
|---|---|---|---|---|---|
| Yes | Ramp Cross Slope LT (%) | 1.9 | No | Ramp Cross Slope RT (%) | 3.6 |

**Remove & Replace Curb Ramp With Two New Directional Ramps or Equivalent.**

**R204.3, R304.5.3, STD 1115**

Total Cost: \$ 4000
