# Access Compliance Report Public Rights-of-Way (Curb Ramps)

| Main Street: COCKSCROW_LN | | Cross Street: HICKORY_BRANCH_RD | | Location: | S |
| ADA ID: RPRK220103143924 | Ramp Type: Type 4 - Parallel | Initial Pass/Fail: Fail | Overall Compliance: No | Severity Score: | 16 |

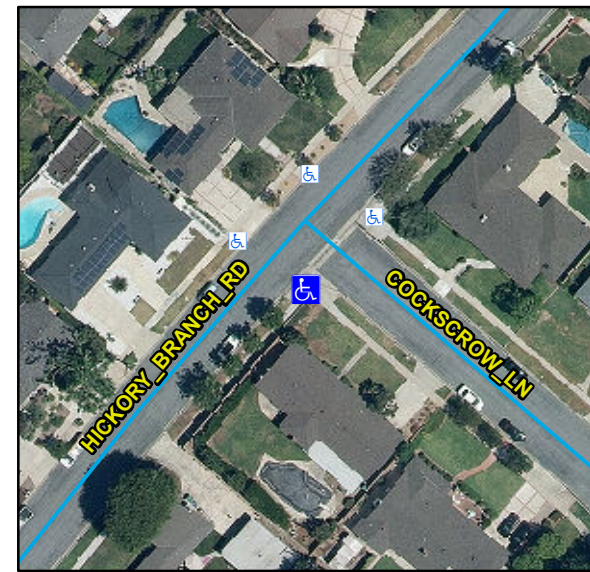
| Compliance | Description | Data | Compliance | Description | Data |
|---|---|---|---|---|---|
| No | Ramp Run Slope LT (%) | 8.5 | Yes | Ramp Run Slope RT (%) | 3.2 |
| Yes | Ramp Cross Slope LT (%) | 1.2 | No | Ramp Cross Slope RT (%) | 3.3 |

Possible Solutions:

**Remove & Replace Curb Ramp With Two New Directional Ramps or Equivalent.**

**R204.3, R304.3.2, R304.5.3, STD 1115**

Total Cost: \$ 4000
