# Access Compliance Report Public Rights-of-Way (Curb Ramps)

Main Street: HICKORY\_BRANCH\_RD Cross Street: RAINBOW\_DR Location: NW

ADA ID: RPRK220103144255 Ramp Type: Type 4 - Parallel Initial Pass/Fail: Fail Overall Compliance: No Severity Score: 16

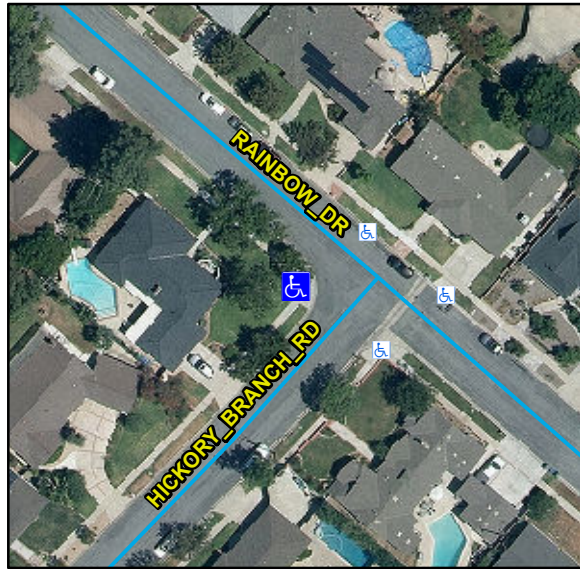
| Compliance | Description | Data | Compliance | Description | Data |
|---|---|---|---|---|---|
| Yes | Ramp Run Slope LT (%) | 4.2 | No | Ramp Run Slope RT (%) | 9.2 |
| No | Ramp Cross Slope LT (%) | 3.6 | Yes | Ramp Cross Slope RT (%) | 0.8 |

Remove & Replace Curb Ramp With Two New Directional Ramps or Equivalent.
