# Access Compliance Report Public Rights-of-Way (Curb Ramps)

Main Street: BULLARD\_RD Cross Street: BULLARD\_RD Location: N

ADA ID: RPRK220103145122 Ramp Type: Type 1 - Perpendicular Diagonal Initial Pass/Fail: Pass Overall Compliance: No Severity Score: 2

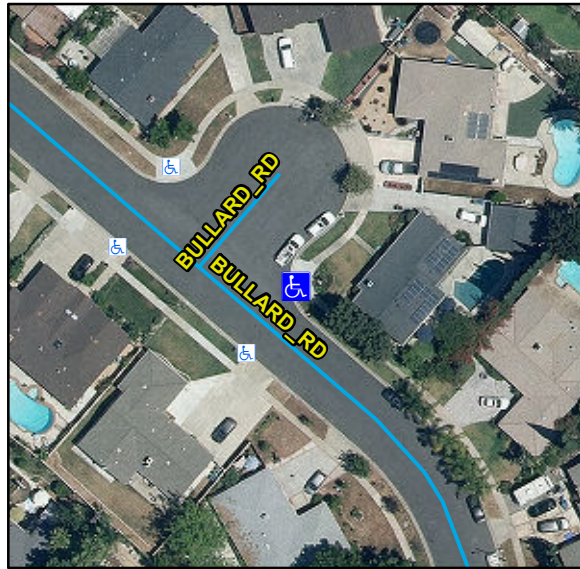
| Compliance | Description | Data | Compliance | Description | Data |
|---|---|---|---|---|---|
| No | Ramp Cross Slope (%) | 2.1 | N/A | Flare Traversable LT | No |
| No | Landing Cross Slope (%) | 3.3 | Yes | DWS Provided | Yes |

**Remove & Replace Curb Ramp With Two New Directional Ramps or Equivalent.**

**R304.5.3, R304.2.1, STD 1115**
