# Access Compliance Report

## Public Rights-of-Way

### (Curb Ramps)

Main Street: BULLARD\_RD Cross Street: BULLARD\_RD Location: E

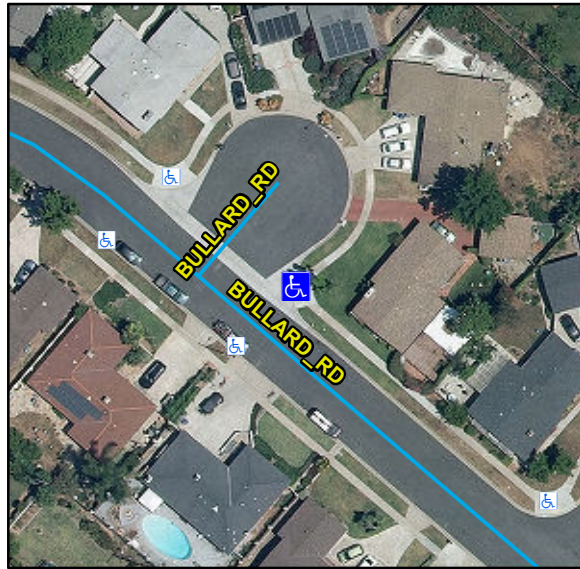
ADA ID: RPRK220103145752 Ramp Type: Type 1 - Perpendicular Diagonal Initial Pass/Fail: Fail Overall Compliance: No Severity Score: 16

| Compliance | Description | Data | Compliance | Description | Data |
|---|---|---|---|---|---|
| No | Ramp Run Slope (%) | 8.5 | N/A | Flare Slope LT (%) | N/A |

**Remove & Replace Curb Ramp With Two New Directional Ramps or Equivalent.**

**R304.2.2, STD 1115**
