# Access Compliance Report Public Rights-of-Way (Curb Ramps)

Main Street: BULLARD\_RD Cross Street: BULLARD\_RD Location: NE

ADA ID: RPRK220103150014 Ramp Type: Type 1 - Perpendicular Diagonal Initial Pass/Fail: Pass Overall Compliance: No Severity Score: 0

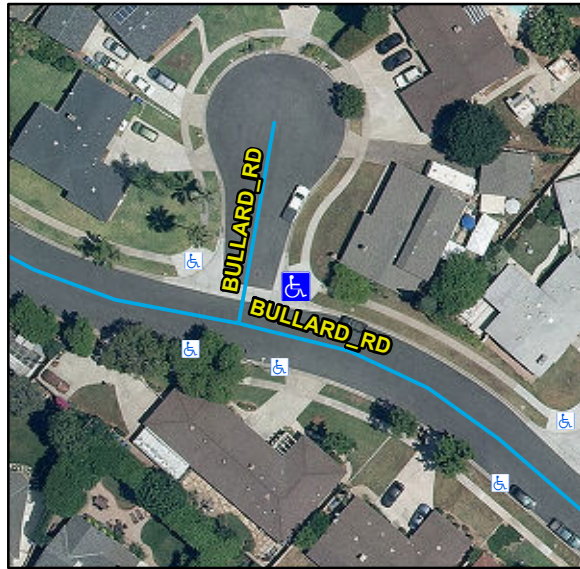
| Compliance | Description | Data | Compliance | Description | Data |
|---|---|---|---|---|---|
| Yes | Gutter Ponding | No | No | Curb Slope | 6.3 |

Remove & Replace Curb Ramp With Two New Directional Ramps or Equivalent.

R304.2.2, R304.2.1, STD 1115
