# Access Compliance Report Public Rights-of-Way (Curb Ramps)

Main Street: BULLARD\_RD Cross Street: BULLARD\_RD Location: N

ADA ID: RPRK220103150439 Ramp Type: Type 1 - Perpendicular Diagonal Initial Pass/Fail: Fail Overall Compliance: No Severity Score: 2

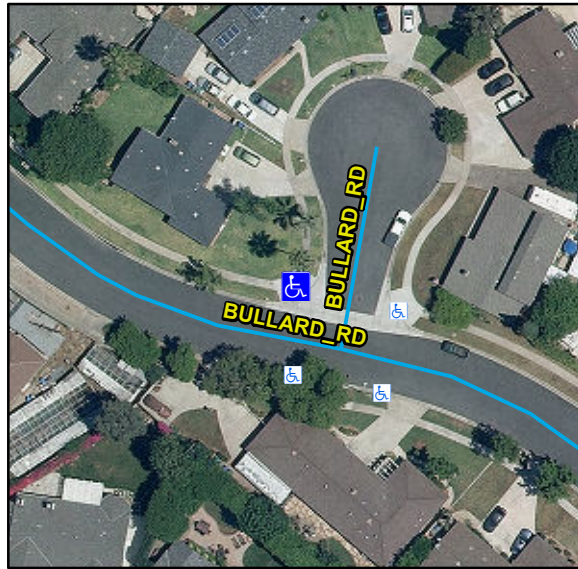
| Compliance | Description | Data | Compliance | Description | Data |
|---|---|---|---|---|---|
| No | Ramp Cross Slope (%) | 2.3 | N/A | Flare Traversable LT | N/A |

Remove & Replace Curb Ramp With Two New Directional Ramps or Equivalent.

R304.5.3, STD 1115
