# Access Compliance Report Public Rights-of-Way (Curb Ramps)

Main Street: DEAN\_ST Cross Street: MELVIN\_WAY Location: NW

ADA ID: RPRK220103151423 Ramp Type: Type 1 - Perpendicular Diagonal Initial Pass/Fail: Fail Overall Compliance: No Severity Score: 15

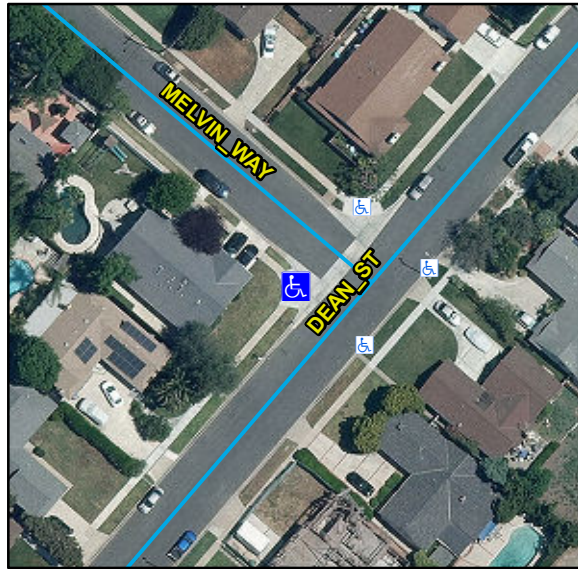
| Compliance | Description | Data | Compliance | Description | Data |
|---|---|---|---|---|---|
| No | Ramp Run Slope (%) | 9.3 | N/A | Flare Slope LT (%) | N/A |

Remove & Replace Curb Ramp With Two New Directional Ramps or Equivalent.

R304.2.2, STD 1115
