# Access Compliance Report Public Rights-of-Way (Curb Ramps)

Main Street: MELVIN\_WAY Cross Street: WOODLAND\_DR Location: S

ADA ID: RPRK220103151900 Ramp Type: Type 1 - Perpendicular Diagonal Initial Pass/Fail: Fail Overall Compliance: No Severity Score: 16

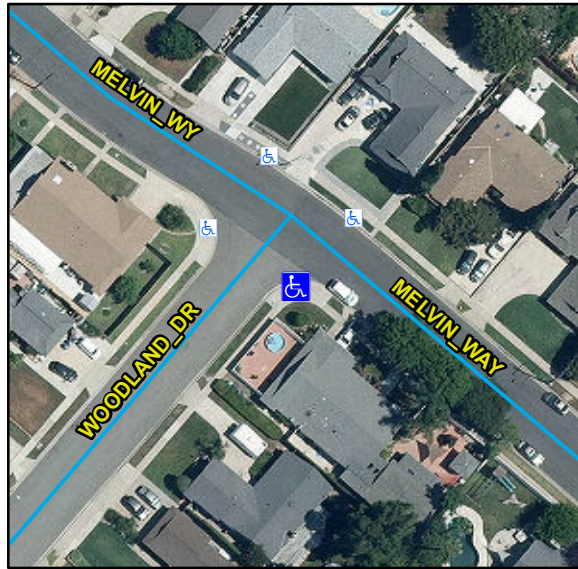
| Compliance | Description | Data | Compliance | Description | Data |
|---|---|---|---|---|---|
| No | Ramp Run Slope (%) | 8.8 | N/A | Flare Slope LT (%) | N/A |
| No | Ramp Cross Slope (%) | 2.4 | N/A | Flare Traversable LT | N/A |

Remove & Replace Curb Ramp With Two New Directional Ramps or Equivalent.

R304.2.2, R304.5.3, STD 1115
