# Access Compliance Report Public Rights-of-Way (Curb Ramps)

| Main Street: GARLAND_AVE | | Cross Street: RED_HILL_AVE | | Location: | N |
| ADA ID: RPRK220103152548 | Ramp Type:Type 1 - Perpendicular Diagonal Initial Pass/Fail: Fail | | Overall Compliance: No | Severity Score: | 15 |

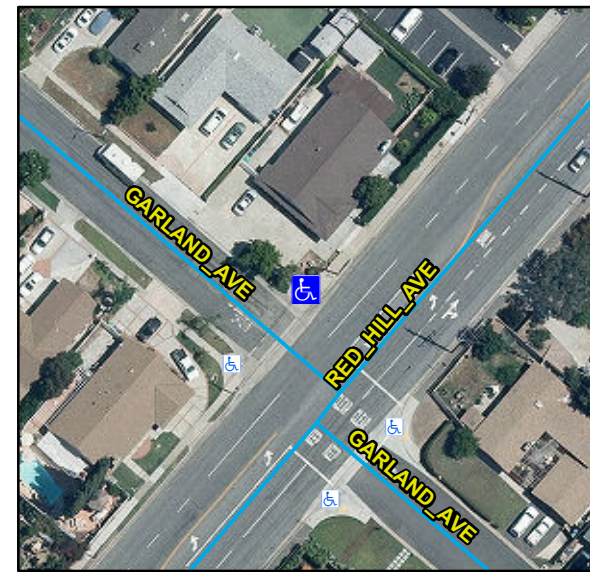
| Compliance | Description | Data | Compliance | Description | Data |
|---|---|---|---|---|---|
| No | Ramp Run Slope (%) | 8.8 | N/A | Flare Slope LT (%) | N/A |
| No | Gutter Lip Height (in) | 0.25 | | Road Run Slope (%) | 0.2 |

**Remove & Replace Curb Ramp With Two New Directional Ramps or Equivalent. Grind Gutter Lip.**

**R204.3, R304.2.2, R302.7.2, STD 1115**
