# Access Compliance Report Public Rights-of-Way (Curb Ramps)

| Main Street: RED_HILL_AVE | | Cross Street: GARLAND_AVE | | Location: | W |
| ADA ID: RPRK220103152833 | Ramp Type: Type 4 - Parallel | Initial Pass/Fail: Fail | Overall Compliance: No | Severity Score: | 2 |

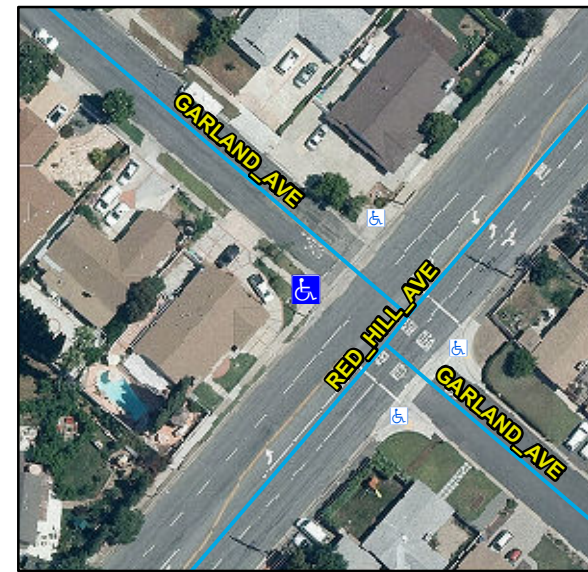
| Compliance | Description | Data | Compliance | Description | Data |
|---|---|---|---|---|---|
| No | Ramp Cross Slope LT (%) | 3.8 | Yes | Ramp Cross Slope RT (%) | 0.9 |

**Remove & Replace Curb Ramp With Two New Directional Ramps or Equivalent.**

**R204.3, R304.5.3, STD 1115**

Total Cost: \$ 4000

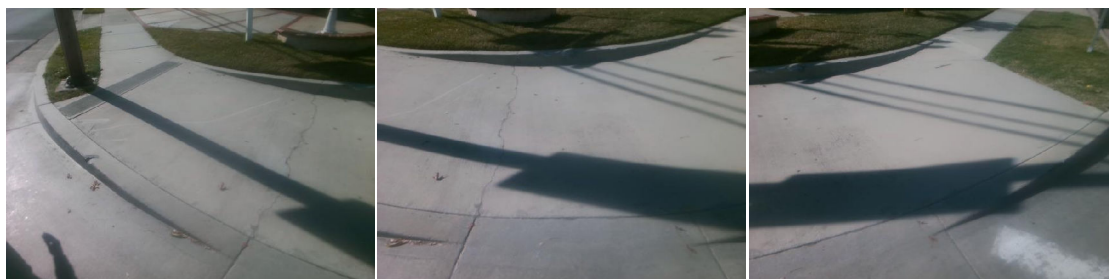
| Compliance | Description | Data | Compliance | Description | Data |
|---|---|---|---|---|---|
| N/A | Ramp Length LT (in) | 109 | N/A | Ramp Length RT (in) | 106 |
| Yes | Ramp Width LT (in) | 101 | Yes | Ramp Width RT (in) | 101 |
| Yes | Ramp Run Slope LT (%) | 4.5 | Yes | Ramp Run Slope RT (%) | 7.2 |
