# Access Compliance Report Public Rights-of-Way (Curb Ramps)

Main Street: DEL\_REY\_DR Cross Street: TIFFANY\_PL Location: W

ADA ID: RPRK220103153304 Ramp Type: Type 1 - Perpendicular Diagonal Initial Pass/Fail: Pass Overall Compliance: No Severity Score: 0

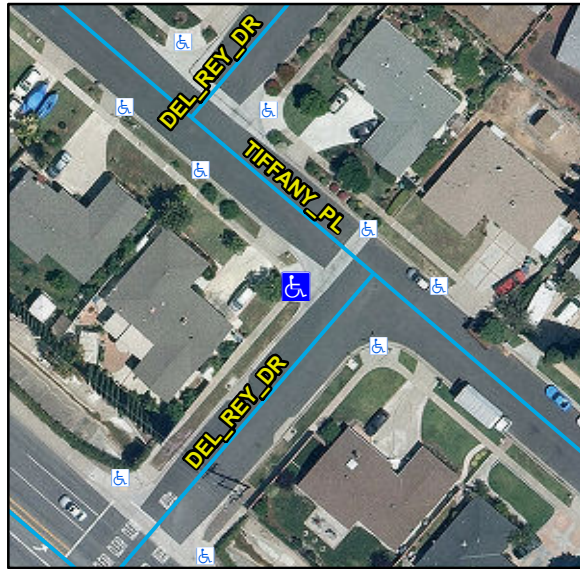
| Compliance | Description | Data | Compliance | Description | Data |
|---|---|---|---|---|---|
| N/A | Landing Movement Obstructed? | Yes | Yes | DWS Contrast | Yes |
| | Landing Movement Type | Curb | Yes | DWS Length (in) | 36 |

Possible Solutions:

Remove & Replace Landing.

OC Std/PROW:

R304.2.1, STD 1115
