# Access Compliance Report Public Rights-of-Way (Curb Ramps)

Main Street: TIFFANY\_PL Cross Street: CHAPLET\_PL Location: N

ADA ID: RPRK220103153835 Ramp Type: Type 4 - Parallel Initial Pass/Fail: Pass Overall Compliance: No Severity Score: 0

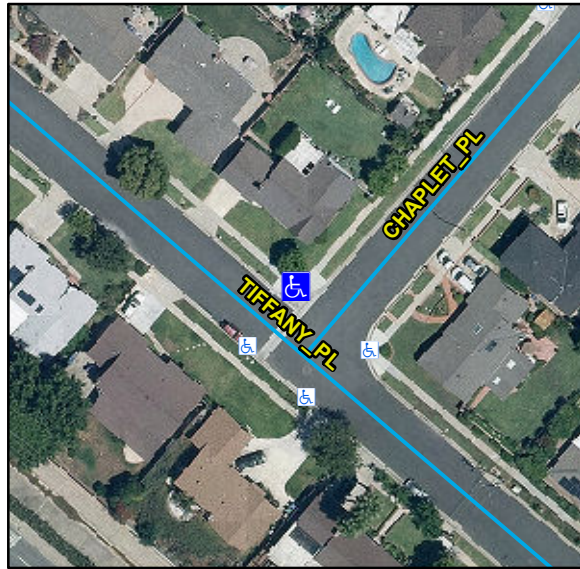
| Compliance | Description | Data | Compliance | Description | Data |
|---|---|---|---|---|---|
| N/A | Landing Movement Obstructed? | No | No | DWS Offset Left (in) | 3 |

Remove & Replace Curb Ramp With Two New Directional Ramps or Equivalent.

R204.3, R305.2, STD 1115

Total Cost: \$ 4000
