# Access Compliance Report Public Rights-of-Way (Curb Ramps)

Main Street: CHAPLET\_PL Cross Street: CAMEO\_DR Location: W

ADA ID: RPRK220103154606 Ramp Type: Type 4 - Parallel Initial Pass/Fail: Fail Overall Compliance: No Severity Score: 16

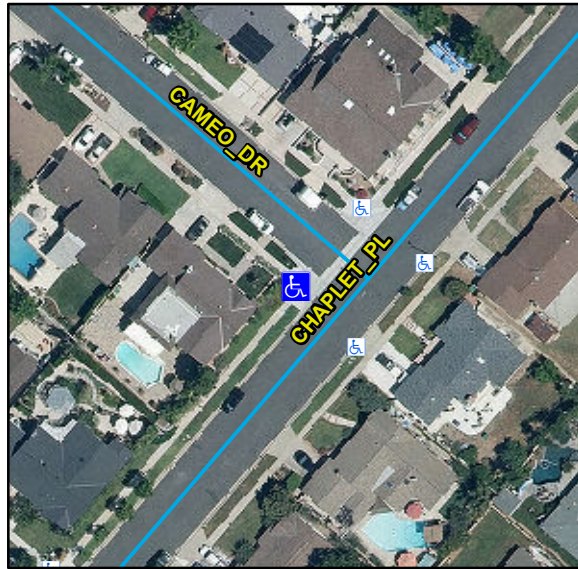
| Compliance | Description | Data | Compliance | Description | Data |
|---|---|---|---|---|---|
| Yes | Ramp Run Slope LT (%) | 2.5 | No | Ramp Run Slope RT (%) | 11 |
| No | Ramp Cross Slope LT (%) | 2.8 | Yes | Ramp Cross Slope RT (%) | 2 |

Remove & Replace Curb Ramp With Two New Directional Ramps or Equivalent.
