# Access Compliance Report Public Rights-of-Way (Curb Ramps)

| Main Street: RAINBOW_DR | | Cross Street: CHAPLET_PL | | Location: | S |
| ADA ID: RPRK220103155738 | Ramp Type: Type 4 - Parallel | Initial Pass/Fail: Fail | Overall Compliance: No | Severity Score: | 16 |

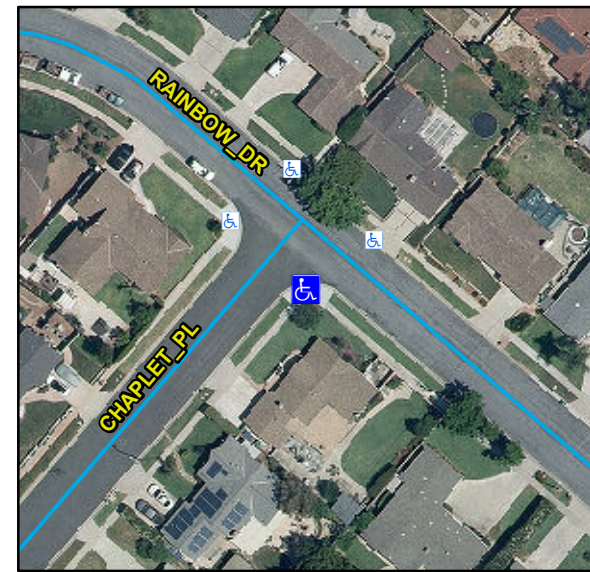
| Compliance | Description | Data | Compliance | Description | Data |
|---|---|---|---|---|---|
| No | Ramp Run Slope LT (%) | 8.4 | Yes | Ramp Run Slope RT (%) | 0.3 |
| No | Ramp Cross Slope LT (%) | 2.2 | No | Ramp Cross Slope RT (%) | 3 |

**Remove & Replace Curb Ramp With Two New Directional Ramps or Equivalent.**

**R304.3.2, R304.5.3, STD 1115**

Total Cost: \$ 4000
