# Access Compliance Report Public Rights-of-Way (Curb Ramps)

| Main Street: LA_LOMA_DR | | Cross Street: HEATHCLIFF_DR | | Location: | N |
| ADA ID: RPRK220107112744 | Ramp Type: Type 4 - Parallel | Initial Pass/Fail: Fail | Overall Compliance: No | Severity Score: | 32 |

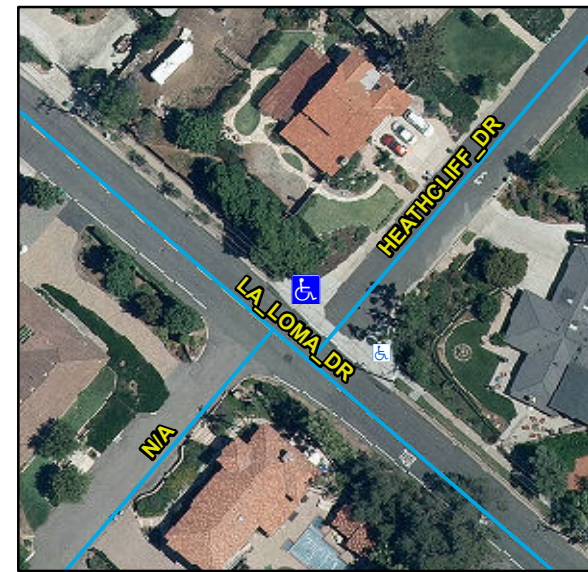
| Compliance | Description | Data | Compliance | Description | Data |
|---|---|---|---|---|---|
| No | Ramp Run Slope LT (%) | 10.1 | No | Ramp Run Slope RT (%) | 16.6 |
| No | Ramp Cross Slope LT (%) | 3.9 | Yes | Ramp Cross Slope RT (%) | 0.4 |

**Remove & Replace Curb Ramp With Two New Directional Ramps or Equivalent.**

**R304.3.2, R304.5.3, STD 1115**

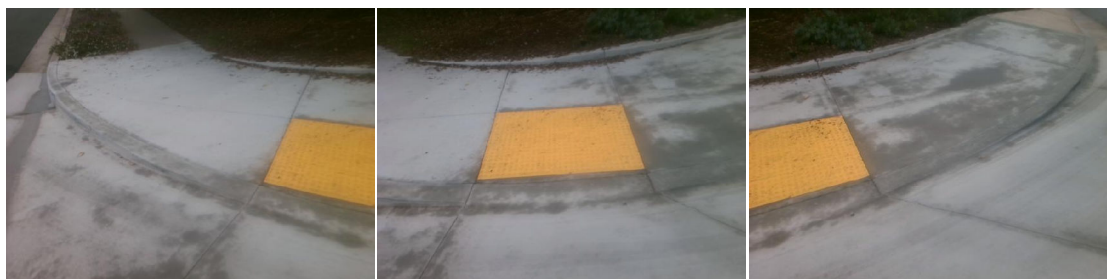
| Compliance | Description | Data | Compliance | Description | Data |
|---|---|---|---|---|---|
| N/A | Ramp Length LT (in) | 107 | N/A | Ramp Length RT (in) | 138 |
| Yes | Ramp Width LT (in) | 90 | Yes | Ramp Width RT (in) | 84 |
