# Access Compliance Report Public Rights-of-Way (Curb Ramps)

Main Street: HEATHCLIFF\_DR Cross Street: LA\_LOMA\_DR Location: E

ADA ID: RPRK220107113129 Ramp Type: Type 4 - Parallel Initial Pass/Fail: Fail Overall Compliance: No Severity Score: 16

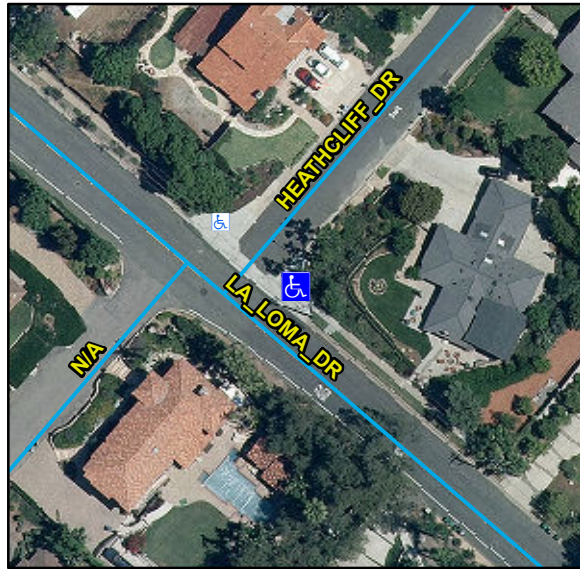
| Compliance | Description | Data | Compliance | Description | Data |
|---|---|---|---|---|---|
| Yes | Ramp Run Slope LT (%) | 2.3 | No | Ramp Run Slope RT (%) | 11.8 |
| No | Ramp Cross Slope LT (%) | 2.2 | Yes | Ramp Cross Slope RT (%) | 0.1 |

Remove & Replace Curb Ramp With Two New Directional Ramps or Equivalent.

R304.5.3, R304.3.2, STD 1115

Total Cost: \$ 4000
