# Access Compliance Report Public Rights-of-Way (Curb Ramps)

Main Street: N/A Cross Street: RED\_HILL\_AVE Location: N

ADA ID: RPRK220107113928 Ramp Type: Type 6 - Directional 1 Initial Pass/Fail: Fail Overall Compliance: No Severity Score: 16

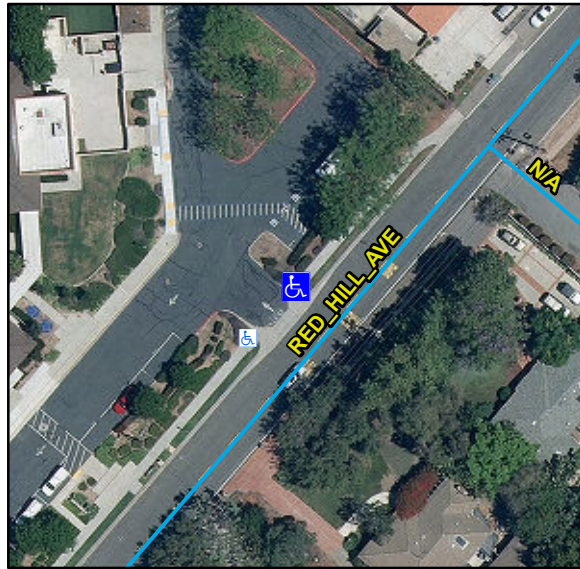
| Compliance | Description | Data | Compliance | Description | Data |
|---|---|---|---|---|---|
| No | Ramp Run Slope (%) | 8.9 | N/A | Flare Slope LT (%) | N/A |

Remove & Replace Entire Ramp.
