# Access Compliance Report Public Rights-of-Way (Curb Ramps)

| Main Street: N/A | | Cross Street: RED_HILL_AVE | | Location: N | |
| ADA ID: RPRK220107114047 | Ramp Type: Type 6 - Directional 1 | Initial Pass/Fail: Pass | Overall Compliance: No | Severity Score: 12 | |

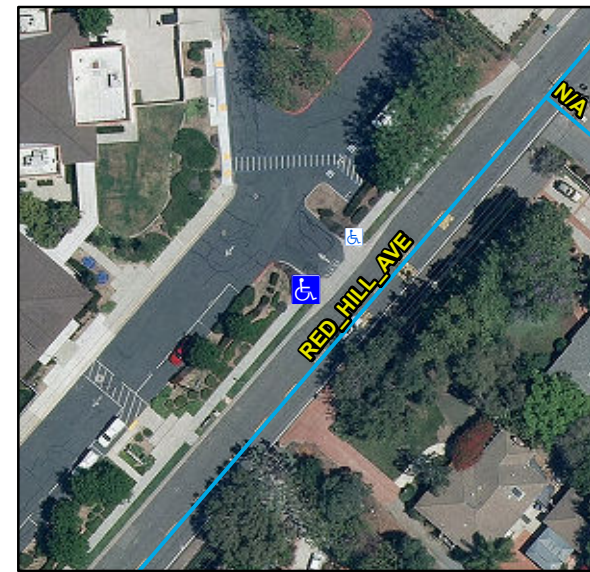
| Compliance | Description | Data | Compliance | Description | Data |
|---|---|---|---|---|---|
| | Addl Para Ramp Right? | No | No | DWS Provided | No |
| No | Landing Run Slope (%) | 2.8 | | DWS Offset Type | N/A |
| No | Landing Cross Slope (%) | 4.1 | N/A | DWS Left Offset (in) | N/A |
| No | Gutter Cross Slope (%) | 2.3 | | Parallel Ramp Side | N/A |

Remove & Replace Entire Ramp. Remove & Replace Gutter.
