# Access Compliance Report Public Rights-of-Way (Curb Ramps)

Main Street: N/A Cross Street: RED\_HILL\_AVE Location: N

ADA ID: RPRK220107114300 Ramp Type: Type 6 - Directional 1 Initial Pass/Fail: Fail Overall Compliance: No Severity Score: 15

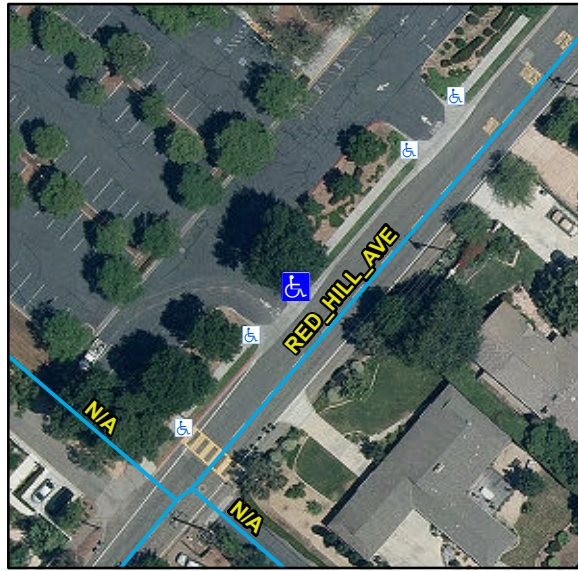
| Compliance | Description | Data | Compliance | Description | Data |
|---|---|---|---|---|---|
| No | Ramp Run Slope (%) | 8.5 | N/A | Flare Slope LT (%) | N/A |

**Remove & Replace Entire Ramp.**

**R304.2.2, STD 1115**
