# Access Compliance Report Public Rights-of-Way (Curb Ramps)

| Main Street: N/A | | Cross Street: RED_HILL_AVE | | Location: N | |
| ADA ID: RPRK220107114556 | Ramp Type: Type 6 - Directional 1 | Initial Pass/Fail: Pass | Overall Compliance: No | Severity Score: 12 | |

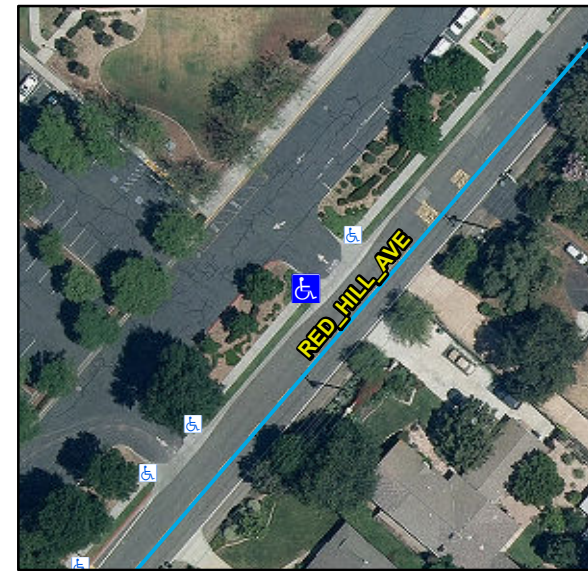
| Compliance | Description | Data | Compliance | Description | Data |
|---|---|---|---|---|---|
| No | Grade Break | No | Yes | Flare Type RT | |
| | Addl Para Ramp Right? | No | No | DWS Provided | No |

**Remove & Replace Entire Ramp.**

**R304.5.2, R305, STD 1115**

Total Cost: \$ 3080

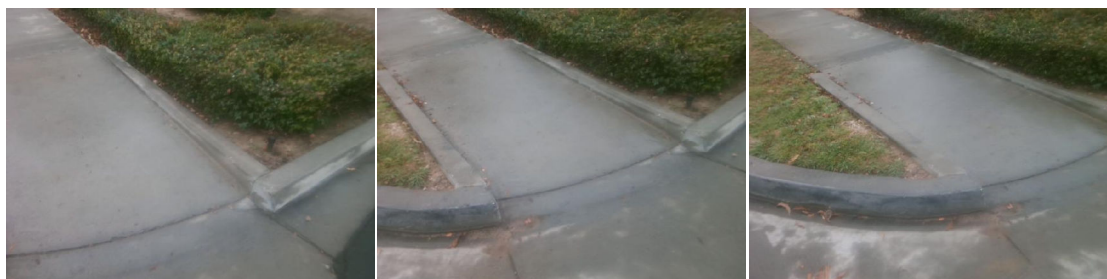
| Compliance | Description | Data | Compliance | Description | Data |
|---|---|---|---|---|---|
| N/A | Ramp Length (in) | 115 | Yes | Flare Type LT | |
| Yes | Ramp Width (in) | 58 | | | Curbed2 |
| Yes | Ramp Run Slope (%) | 2.2 | N/A | Flare Slope LT (%) | N/A |
| Yes | Ramp Cross Slope (%) | 1.7 | N/A | Flare Traversable LT | N/A |
