# Access Compliance Report Public Rights-of-Way (Curb Ramps)

Main Street: N/A Cross Street: RED\_HILL\_AVE Location: N

ADA ID: RPRK220107114753 Ramp Type: Type 6 - Directional 1 Initial Pass/Fail: Pass Overall Compliance: No Severity Score: 16

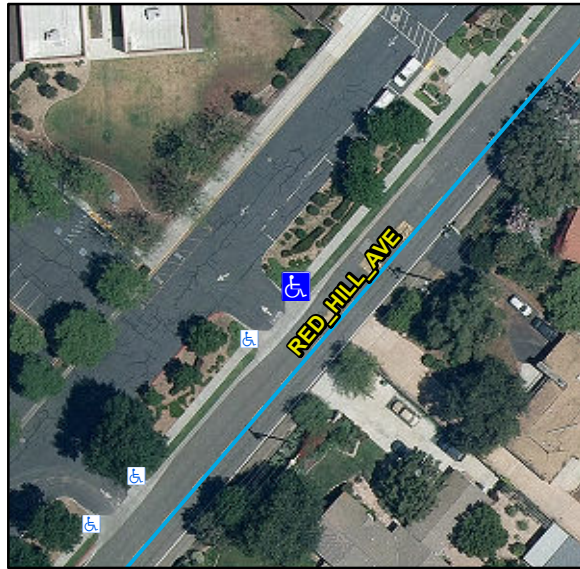
| Compliance | Description | Data | Compliance | Description | Data |
|---|---|---|---|---|---|
| No | Grade Break | No | Yes | Flare Type RT | |
| | Addl Para Ramp Right? | No | No | DWS Provided | No |
| No | Landing Run Slope (%) | 2.6 | | DWS Offset Type | N/A |
| No | Gutter Run Slope (%) | 6 | | Road Cross Slope (%) | N/A |
| No | Gutter Cross Slope (%) | 8.7 | | Parallel Ramp Side | N/A |

Remove & Replace Entire Ramp. Remove & Replace Gutter.
