# Access Compliance Report Public Rights-of-Way (Curb Ramps)

Main Street: N/A Cross Street: RED\_HILL\_AVE Location: N

ADA ID: RPRK220107115043 Ramp Type: Type 6 - Directional 1 Initial Pass/Fail: Pass Overall Compliance: No Severity Score: 16

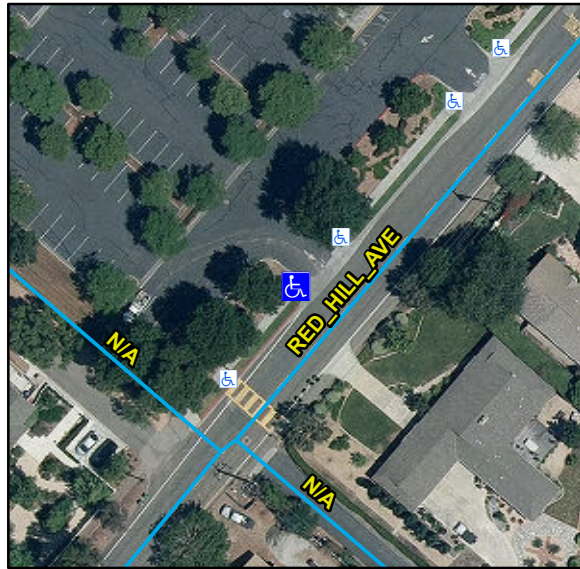
| Compliance | Description | Data | Compliance | Description | Data |
|---|---|---|---|---|---|
| No | Grade Break | No | Yes | Flare Type RT | |
| | Addl Para Ramp Right? | No | No | DWS Provided | No |
| No | Landing Run Slope (%) | 2.6 | | DWS Offset Type | N/A |
| No | Gutter Run Slope (%) | 6.8 | | Road Cross Slope (%) | N/A |
| No | Gutter Cross Slope (%) | 7.2 | | Parallel Ramp Side | N/A |

Remove & Replace Entire Ramp. Remove & Replace Gutter.
