# Access Compliance Report Public Rights-of-Way (Curb Ramps)

| Main Street: RED_HILL_AVE | Cross Street: N/A | Location: W |

| ADA ID: RPRK220107115255 | Ramp Type:Type 1 - Perpendicular | Initial Pass/Fail: Fail | Overall Compliance: No | Severity Score: 2 |

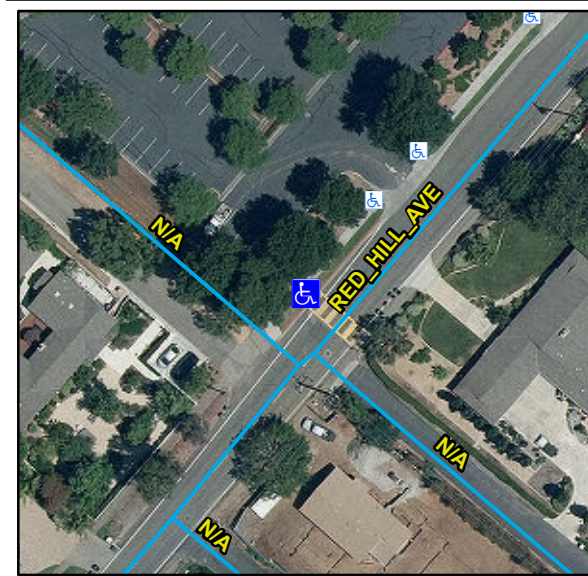
| Compliance | Description | Data | Compliance | Description | Data |
|---|---|---|---|---|---|
| No | Ramp Cross Slope (%) | 3.2 | N/A | Flare Traversable LT | N/A |

**Remove & Replace Entire Ramp.**

**R304.5.3, STD 1115**

Total Cost: \$ 3080

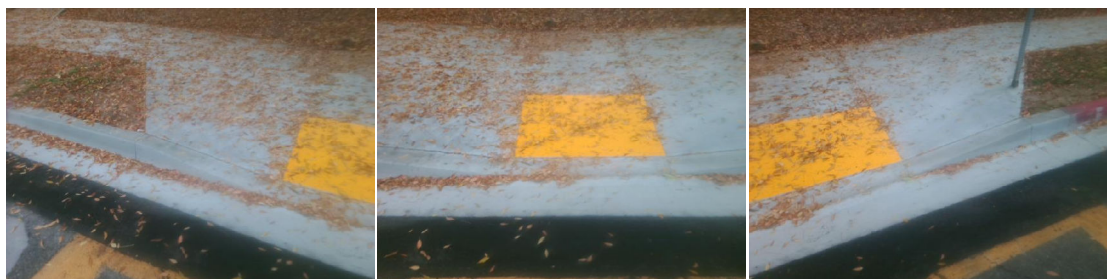
| Compliance | Description | Data | Compliance | Description | Data |
|---|---|---|---|---|---|
| Yes | Overall Surface Condition: Acceptable | | Yes | Perp Joint Present | Yes |
| | Cross Gutter Present? | No | | Spandrel Present? | No |

Possible Solutions:
