# Access Compliance Report Public Rights-of-Way (Curb Ramps)

Main Street: RED\_HILL\_AVE Cross Street: N/A Location: W

ADA ID: RPRK220107115858 Ramp Type: Type 1 - Perpendicular Diagonal Initial Pass/Fail: Pass Overall Compliance: No Severity Score: 25

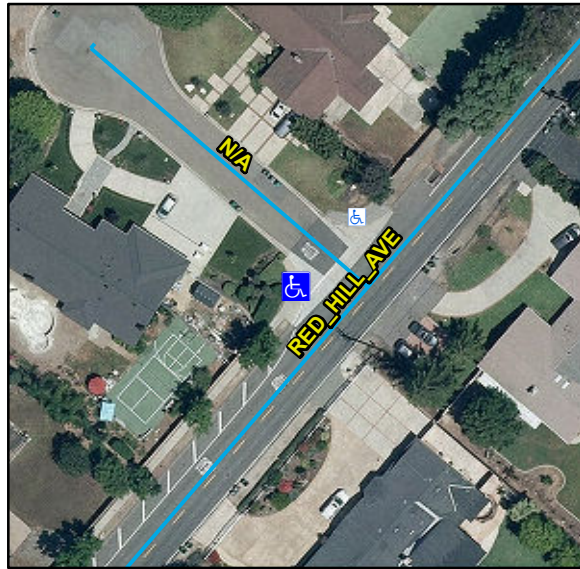
R304.2.1, R304.2.2-Perp, R304.3.2-Para, R304.5.3, R305, R304.5.4, STD 1115

Remove & Replace Curb Ramp With Two New Directional Ramps or Equivalent. Remove & Replace Gutter.
