# Access Compliance Report Public Rights-of-Way (Curb Ramps)

Main Street: N/A Cross Street: RED\_HILL\_AVE Location: N

ADA ID: RPRK220107120151 Ramp Type: Type 7 - Directional 2 Initial Pass/Fail: Fail Overall Compliance: No Severity Score: 15

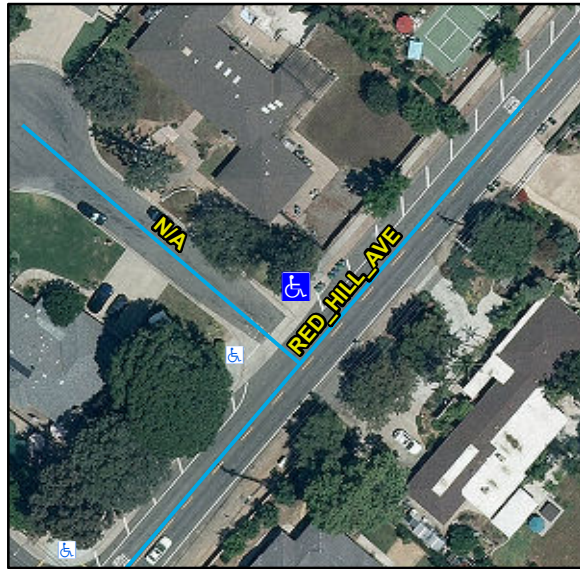
| Compliance | Description | Data | Compliance | Description | Data |
|---|---|---|---|---|---|
| No | Ramp Run Slope (%) | 9.9 | N/A | Flare Slope LT (%) | N/A |
| No | Gutter Lip Height (in) | 0.25 | | Road Run Slope (%) | 0.6 |

Remove & Replace Curb Ramp With Two New Directional Ramps or Equivalent. Grind Gutter Lip.

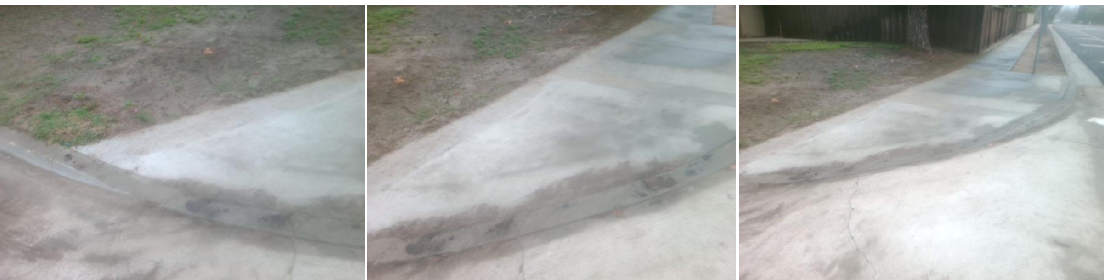
| Compliance | Description | Data | Compliance | Description | Data |
|---|---|---|---|---|---|
| Yes | Overall Surface Condition | Acceptable | No | Perp Joint Present | No |
| | Cross Gutter Present? | Yes | | Spandrel Present? | Yes |

R204.3, R304.2.2, R302.7.2, STD 1115
