# Access Compliance Report Public Rights-of-Way (Curb Ramps)

Main Street: RED\_HILL\_AVE Cross Street: N/A Location: N

ADA ID: RPRK220107120512 Ramp Type: Type 1 - Perpendicular Diagonal Initial Pass/Fail: Pass Overall Compliance: No Severity Score: 12

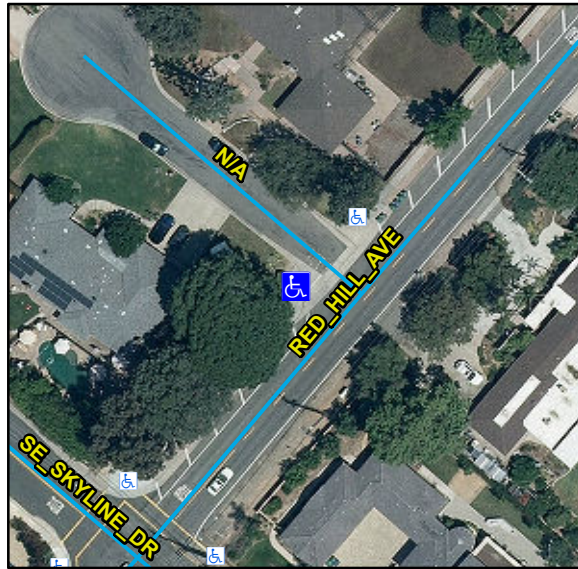
| Compliance | Description | Data | Compliance | Description | Data |
|---|---|---|---|---|---|
| No | Landing Run Slope (%) | 3.1 | N/A | Flare Traversable RT | No |
| No | Gutter Run Slope (%) | 7.8 | | Road Cross Slope (%) | 7 |

Remove & Replace Landing. Remove & Replace Gutter.

R304.2.1, R304.2.2-Perp, R304.3.2-Para, R304.5.4, STD 1115
