# Access Compliance Report Public Rights-of-Way (Curb Ramps)

| Main Street: LA_COLINA_DR | | Cross Street: RED_HILL_AVE | | Location: | S |
| ADA ID: RPRK220107121039 | Ramp Type: Type 7 - Directional 2 | Initial Pass/Fail: Fail | Overall Compliance: No | Severity Score: | 2 |

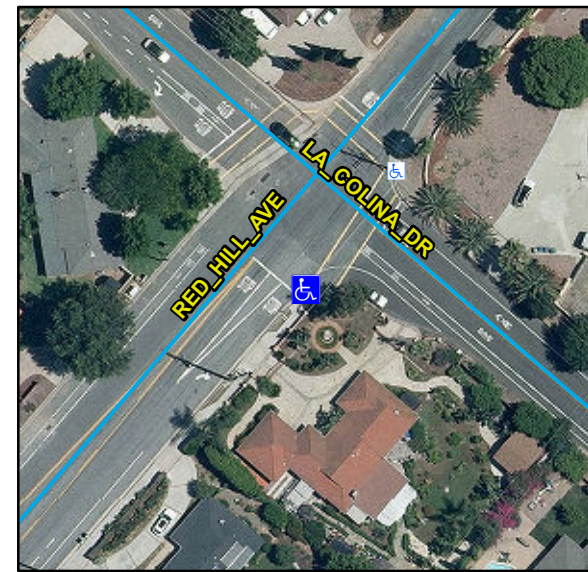
| Compliance | Description | Data | Compliance | Description | Data |
|---|---|---|---|---|---|
| No | Ramp Cross Slope (%) | 2.3 | N/A | Flare Traversable LT | N/A |
| No | Gutter Lip Height (in) | 0.25 | | Road Run Slope (%) | N/A |

Possible Solutions:

**Remove & Replace Entire Ramp. Grind Gutter Lip.**

**R304.5.3, R302.7.2, STD 1115**

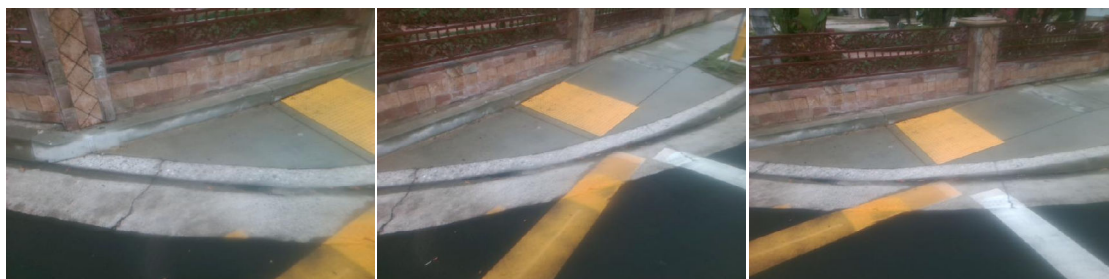
| Compliance | Description | Data | Compliance | Description | Data |
| N/A | Ramp Length (in) | 160 | N/A | Flare Type LT | |
| Yes | Ramp Width (in) | 48 | | | N/A |
| Yes | Ramp Run Slope (%) | 7.2 | N/A | Flare Slope LT (%) | N/A |
