# Access Compliance Report Public Rights-of-Way (Curb Ramps)

Main Street: RED\_HILL\_AVE Cross Street: SIERRA\_ALTA\_DR Location: W

ADA ID: RPRK220107121502 Ramp Type: Type 4 - Parallel Initial Pass/Fail: Pass Overall Compliance: No Severity Score: 0

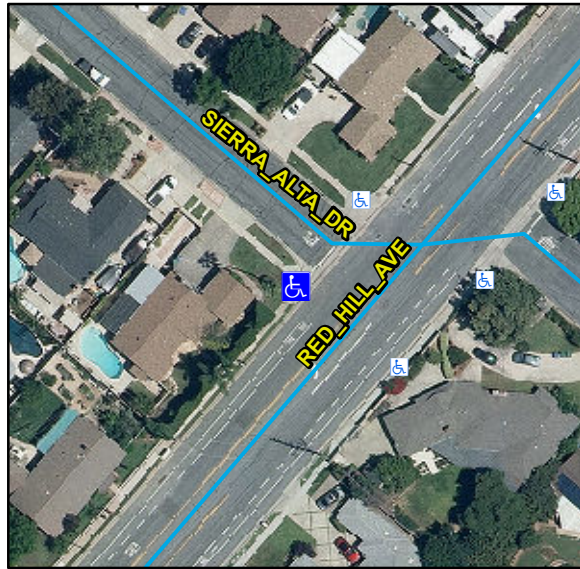
| Compliance | Description | Data | Compliance | Description | Data |
|---|---|---|---|---|---|
| No | Landing Cross Slope (%) | 2.1 | | DWS Offset Type | Single |

Remove & Replace Landing.

R304.5.3, STD 1115
