# Access Compliance Report Public Rights-of-Way (Curb Ramps)

Main Street: BLAIR\_LN Cross Street: KEITH\_PL Location: SE

ADA ID: RPRK220107122855 Ramp Type: Type 7 - Directional 2 Initial Pass/Fail: Fail Overall Compliance: No Severity Score: 15

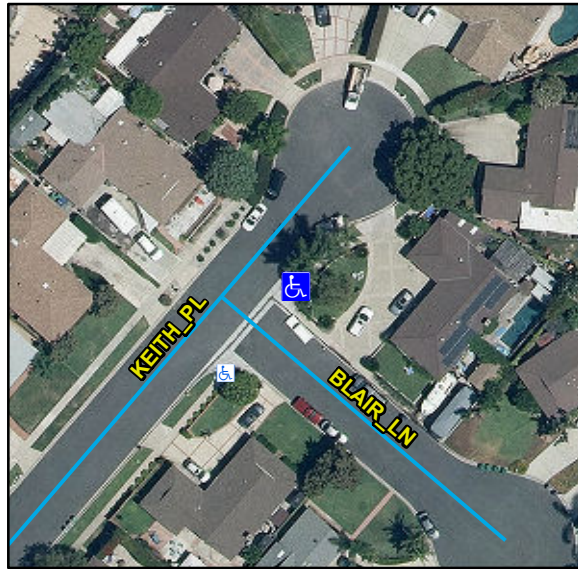
| Compliance | Description | Data | Compliance | Description | Data |
|---|---|---|---|---|---|
| No | Ramp Run Slope (%) | 8.6 | N/A | Flare Slope LT (%) | N/A |

**Remove & Replace Entire Ramp.**

**R304.2.2, STD 1115**

\$ 3080
