# Access Compliance Report Public Rights-of-Way (Curb Ramps)

Main Street: CAMEO\_DR Cross Street: WOODLAWN\_AVE Location: N

ADA ID: RPRK220107125340 Ramp Type: Type 1 - Perpendicular Diagonal Initial Pass/Fail: Fail Overall Compliance: No Severity Score: 15

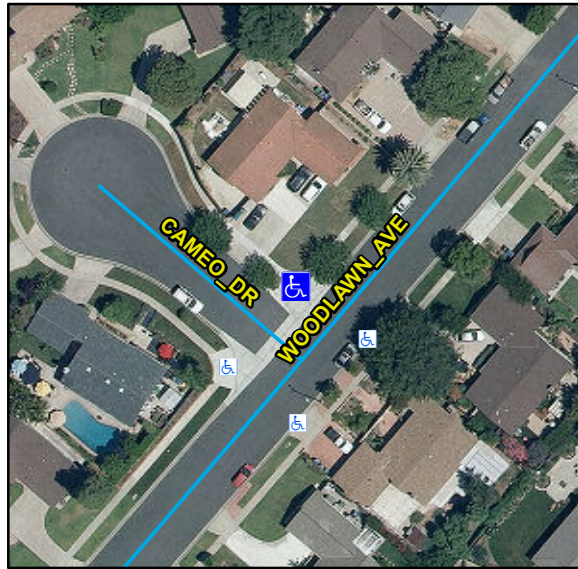
| Compliance | Description | Data | Compliance | Description | Data |
|---|---|---|---|---|---|
| No | Ramp Run Slope (%) | 9.2 | N/A | Flare Slope LT (%) | N/A |

Remove & Replace Curb Ramp With Two New Directional Ramps or Equivalent.

R304.2.2, STD 1115
