# Access Compliance Report Public Rights-of-Way (Curb Ramps)

Main Street: WOODLAWN\_AVE Cross Street: CHARLOMA\_DR Location: SW

ADA ID: RPRK220107125638 Ramp Type: Type 1 - Perpendicular Diagonal Initial Pass/Fail: Pass Overall Compliance: No Severity Score: 2

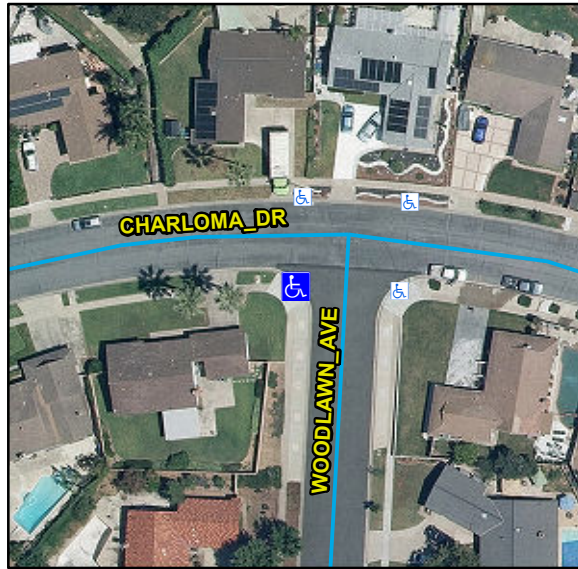
| Compliance | Description | Data | Compliance | Description | Data |
|---|---|---|---|---|---|
| No | Ramp Cross Slope (%) | 3.3 | N/A | Flare Traversable LT | Yes |
| No | Landing Cross Slope (%) | 4.6 | Yes | DWS Provided | Yes |

Remove & Replace Curb Ramp With Two New Directional Ramps or Equivalent.

R304.5.3, STD 1115

Total Cost: \$ 6160
